Lakeside Park Updated 5-Year Street Program (2023-2027)

PREPARED FOR
City of Lakeside Park, Kentucky
Address
9 Buttermilk Pike
Lakeside Park, Kentucky 41017

ISSUED: July 12, 2022

Project Number: 220279

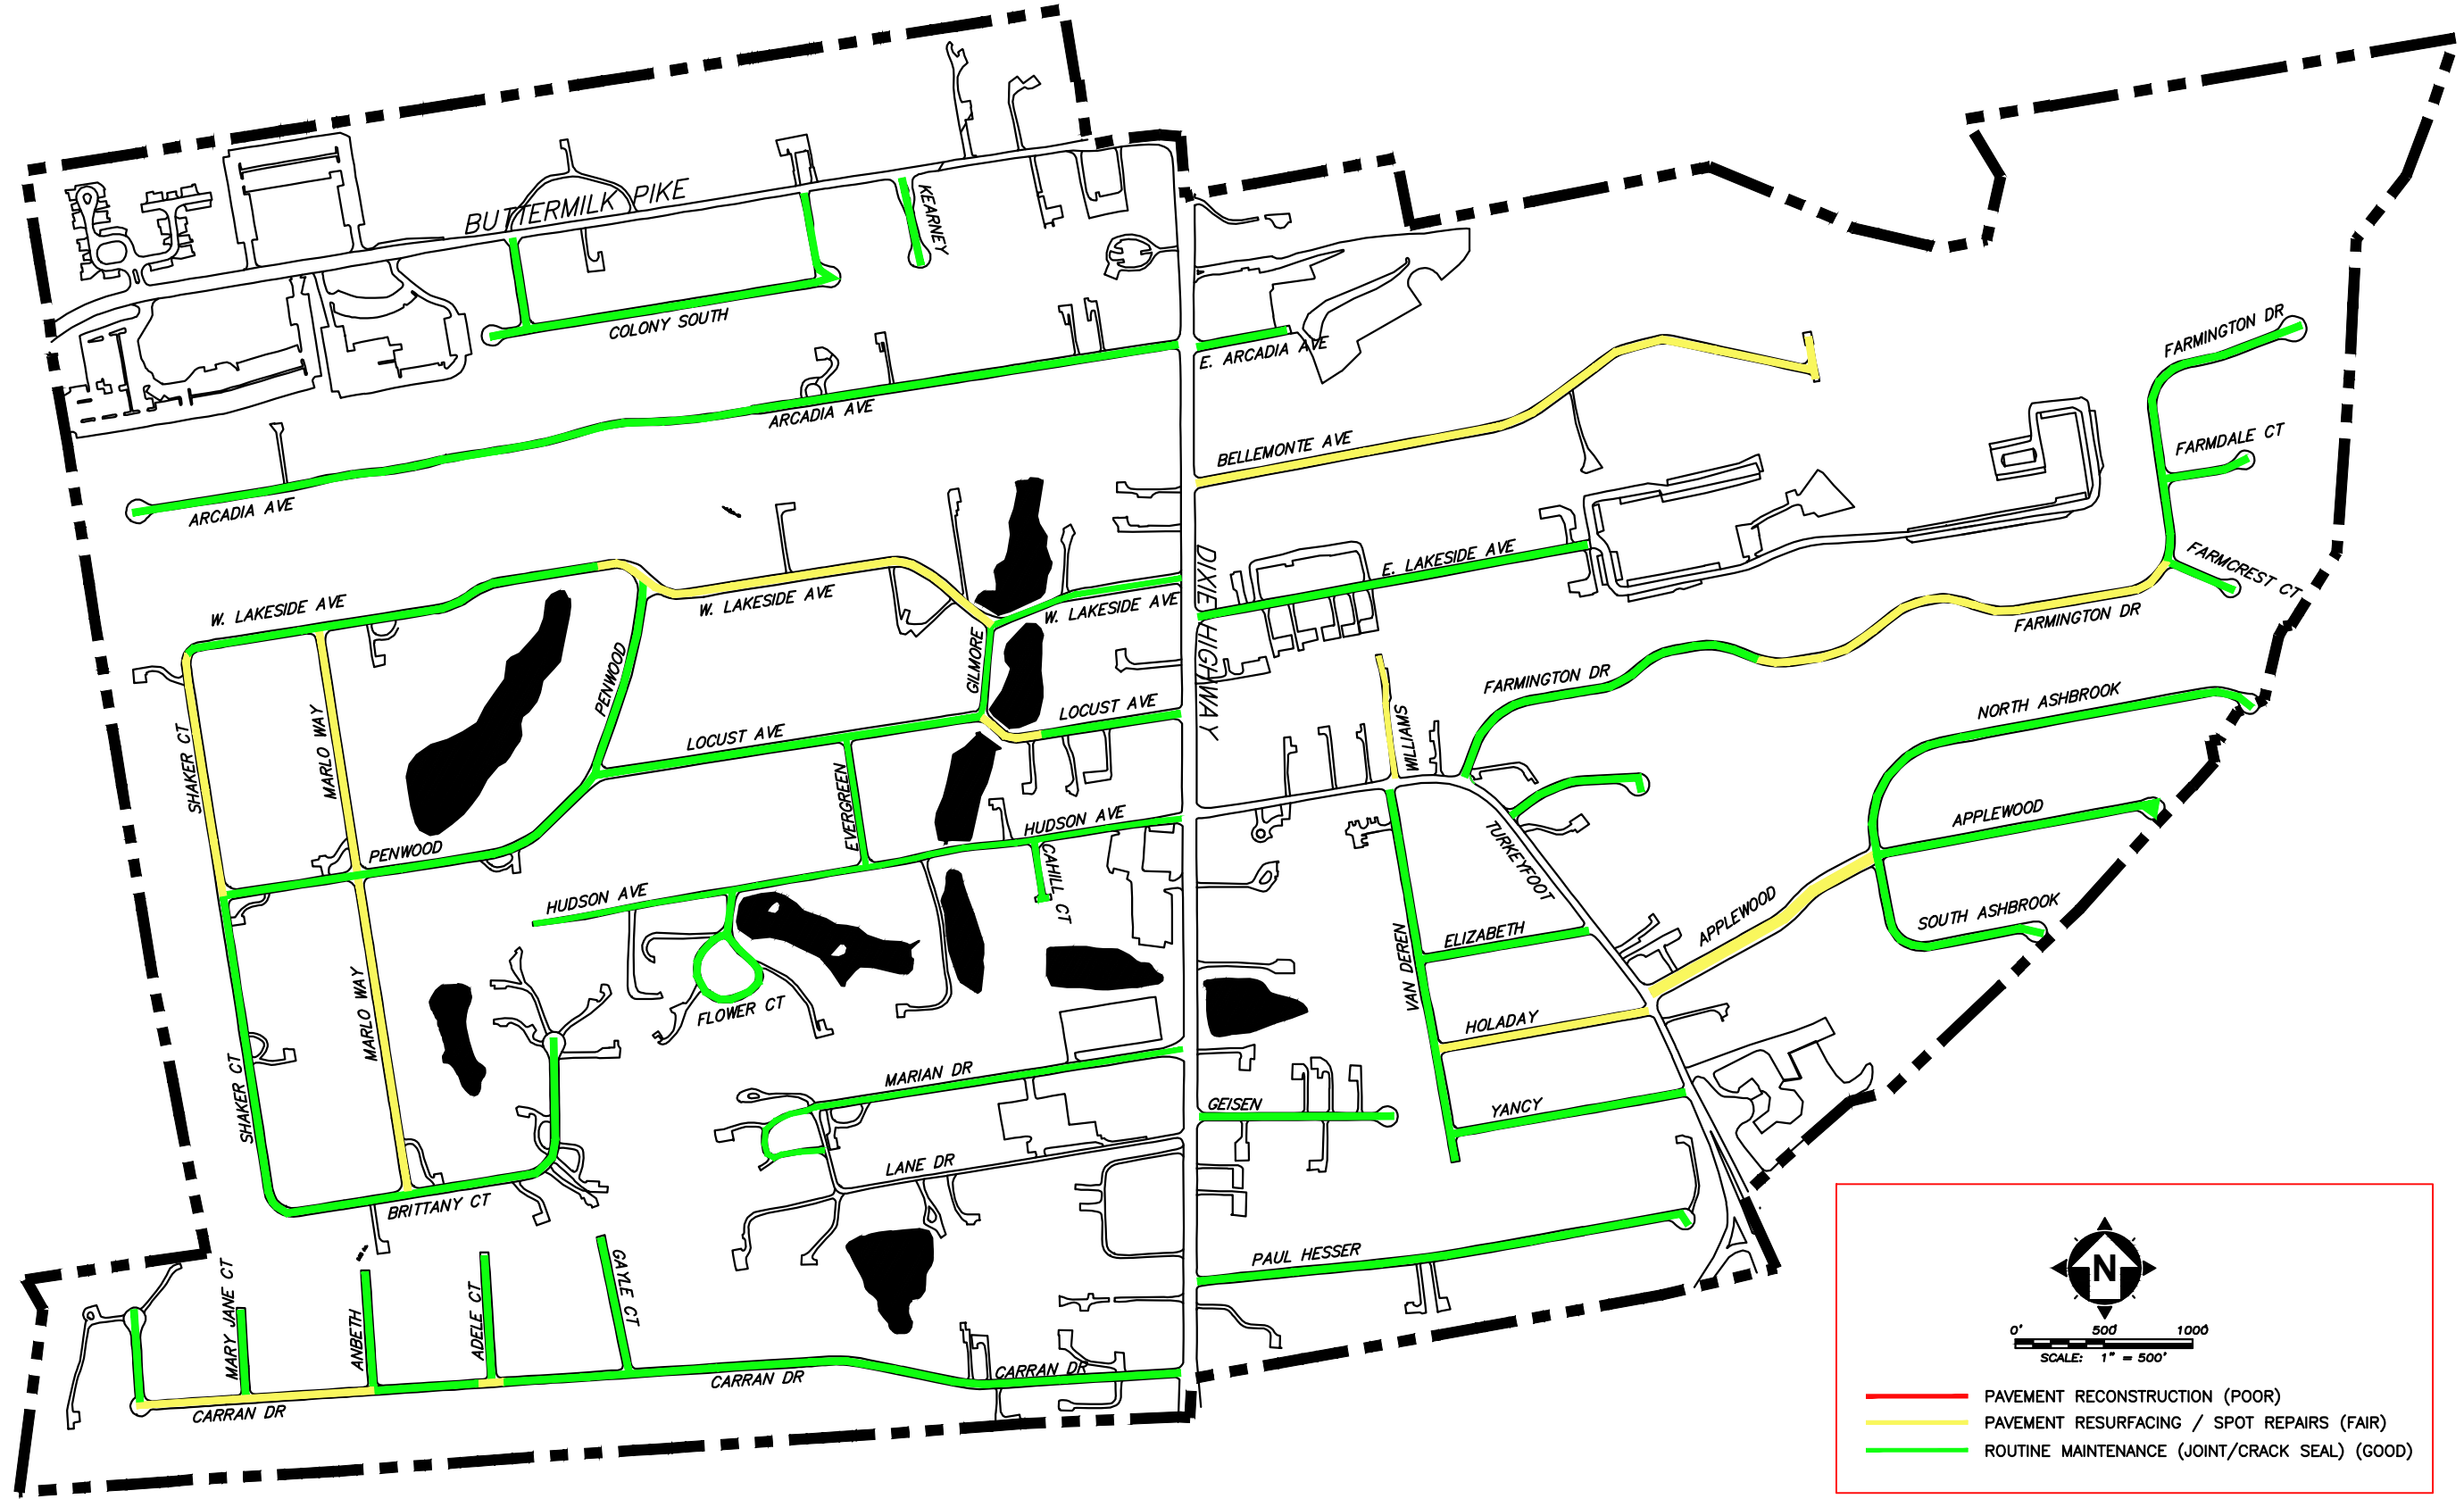
C1 - STREET RATING SUMMARY

— PAVEMENT RECONSTRUCTION (POOR)
— PAVEMENT RESURFACING / SPOT REPAIRS (FAIR)
— ROUTINE MAINTENANCE (JOINT/CRACK SEAL) (GOOD)
